RESULTS

The Juanita Creek assessments began where Juanita Creek enters Lake Washington, and ended approximately 100 m upstream of I-405. An average of 35% of each segment (range: 27%-48%) was surveyed (Table 1, Figure 3). (For a complete description of the start and ending locations of the assessed reaches, see Appendix A.)

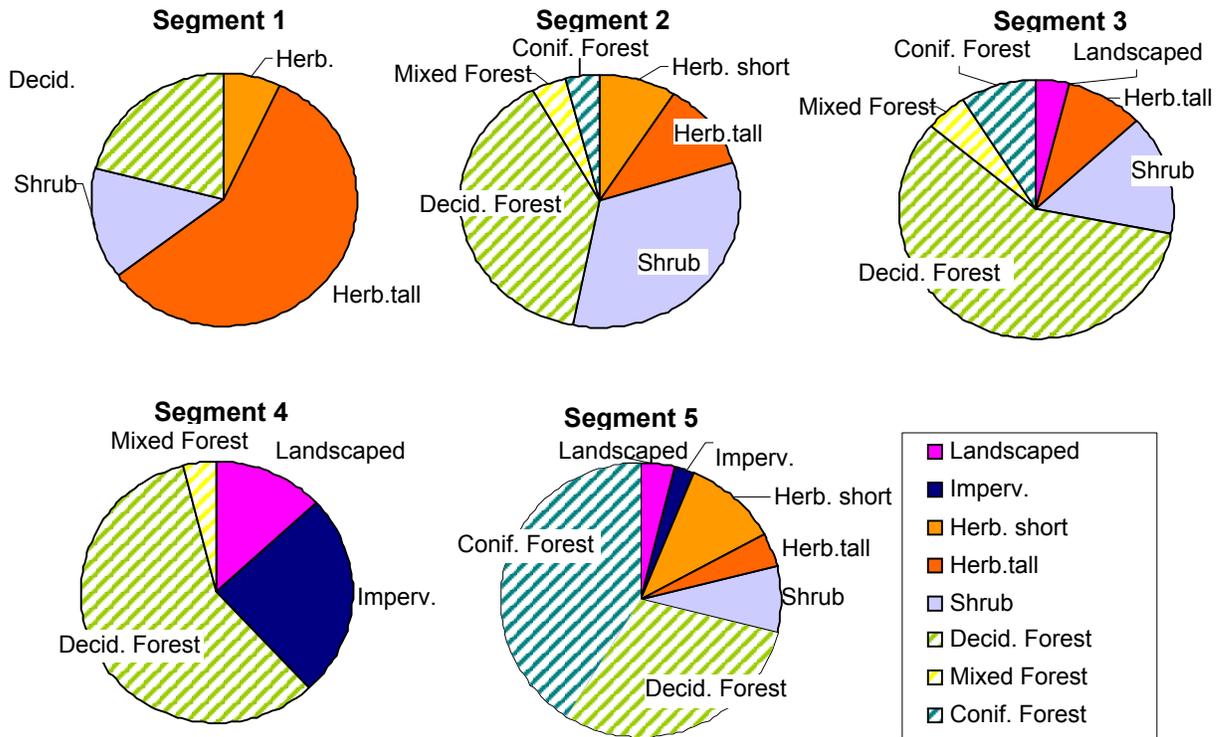
The riparian corridor of Juanita Creek is fragmented, with a maximum of 72% forest coverage found in segment 3. Very little of this remaining riparian forest is coniferous, which suggests that adequate long lasting LWD are not present in this stream ecosystem.

- The riparian corridor of Juanita Creek segments was generally increasingly forested (21%-72%) as one moved upstream
- The riparian corridor of segment 1 was classified as only 21% forested, entirely by deciduous tree species. Most riparian cover in this segment was classified as tall, herbaceous (Table 3, Figure 4).
- The riparian corridor of segment 2 was classified as 44% forested, primarily by deciduous species. The second most predominant vegetation class was shrubs.
- Segments 1-4 had very little of the riparian corridor forested by coniferous species (0-9%).
- A substantial coniferous component was present in segment 5 (41%).
- Blackberry (*R. discolor* or *R. laciniatus*) was present in all segments, and dominant in many reaches (Table 4).

Figure 1. Riparian vegetation composition in Juanita Creek assessment segments.

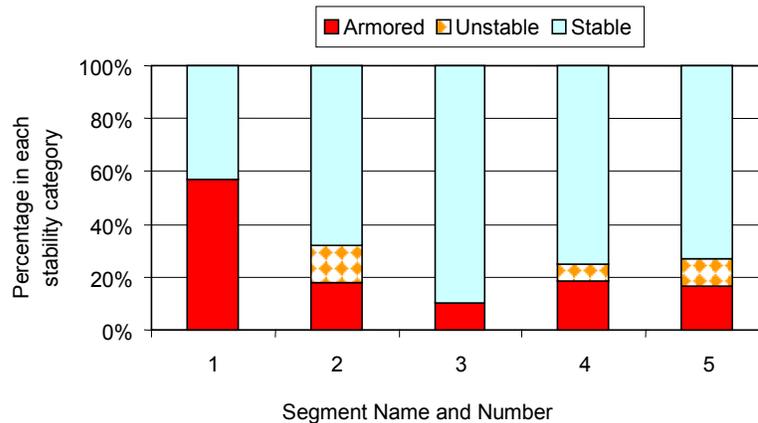
Stable streambanks were the dominant condition in four of five segments of Juanita Creek. The percentage of streambank armoring was less than 20% in all segments, except segment 1 where 57% of the banks were armored. (Figure 5).

Figure 2. Streambank stability of Juanita Creek segments.

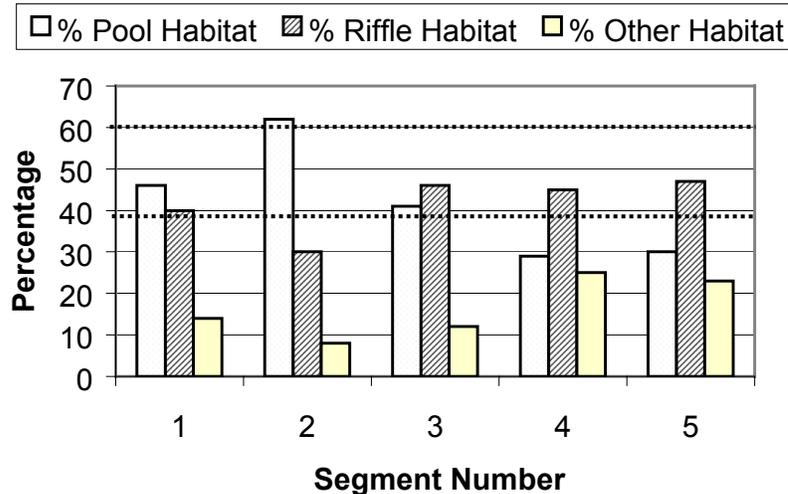
Pool to riffle ratios in Juanita Creek ranged from 2:1 to 1:2 (segment 2 and segments 4 and 5, respectively). Segments 1 and 3 had ratios of 1:1. Pool frequencies met suggested “properly functioning conditions” of 35/km (NOAA 1996) in every segment but segment 5 which had 28 pools /km. The percentage of riffle habitat in Juanita Creek was greater than or equal to 40% in four out of five segments (Figure 6). Mean pool depths were less than 0.5 m in all segments (Table 8). The distribution of the pool depths indicate that 69% of the pools were less than 0.5 m in depth and only 1% of the pools were greater than 1 m in depth (Figure 7).

Figure 3. The percent habitat composition by area of Juanita Creek segments. Optimal habitat distribution is 1:1 pool to riffle ratio; the percentage of each should be between 40% and 60%. Glides are the predominant habitat classified as “other,” however, runs are also categorized as other (Peterson et al. 1992).

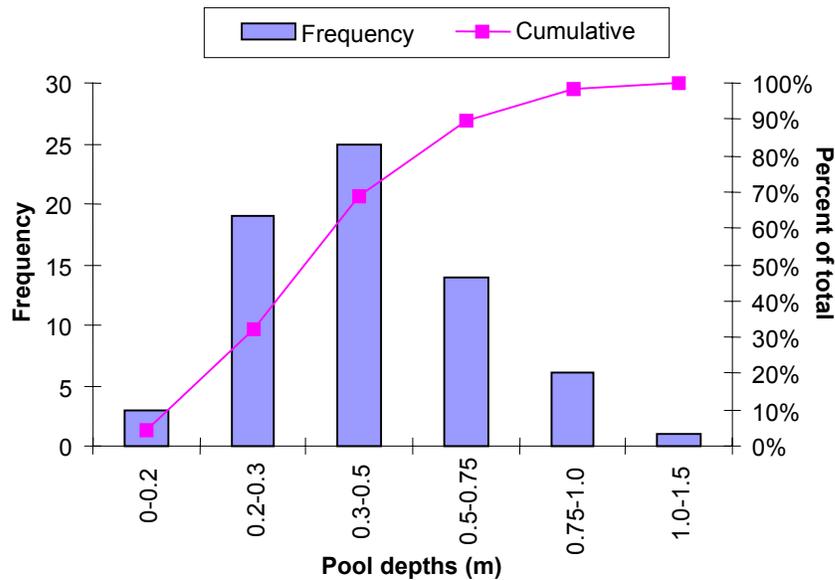
Figure 4. The distribution of pool depths in all assessed reaches of Juanita Creek. The cumulative distribution is shown by the line graph. Sixty-nine percent of the pools assessed were 0-0.5 meters deep.

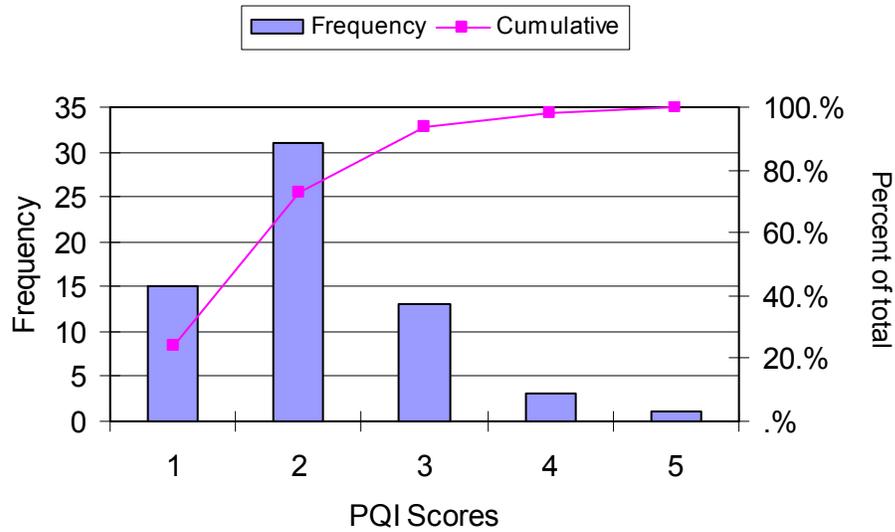
Although pool frequencies in four of the five segments met the NMFS’ properly functioning conditions, the quality of the pools was generally poor. Pools received a higher Pool Quality Index

(PQI) rating if they were deep, large in relation to the size of the channel, and had additional features that would provide cover for fish such as woody debris, overhanging banks, or vegetation. The mean pool quality index was 2, which reflects low overall pool quality, and only two pools out of 68 were rated 5. Seventy-three percent of the pools assessed were rated 1 or 2 (Figure 8, Table 8).

Figure 5. The distribution of PQL scores in all assessed reaches of Juanita Creek. The cumulative distribution is shown by the line graph. Seventy-three percent of the pools assessed were rated low (1 or 2).
